Rotted Beam Repair

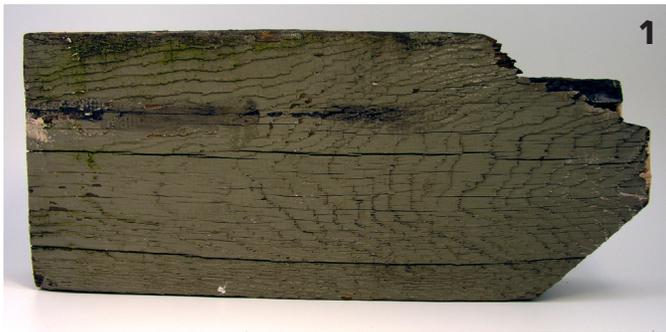
The beam end shown in profile in Photo 1 was the outboard section of a cantilevered beam. This was originally cut off and a new piece sistered in to replace the rotted section. The contractor needed some SculpWood for a rot pocket left in the main section. We took his beam end and showed him how much easier and less expensive it would be to repair the beam ends rather than replace them. The nine photo set shows how this can be done using RotFix and SculpWood Putty and Paste.

The beam end is 18 inches long, 8 inches high and 5 inches thick. The rotted wood has been removed at this stage and borates have been applied. Note that upper right corner and right end have rotted away. The rot extended down into the diagonal cut. Note also the two splits in the wood. The upper one extended through the rotted area to the face on the other side and allowed the far face to be pushed inward. The task is to return the beam back to its original profile as well as rebuild the area where the rot was removed.

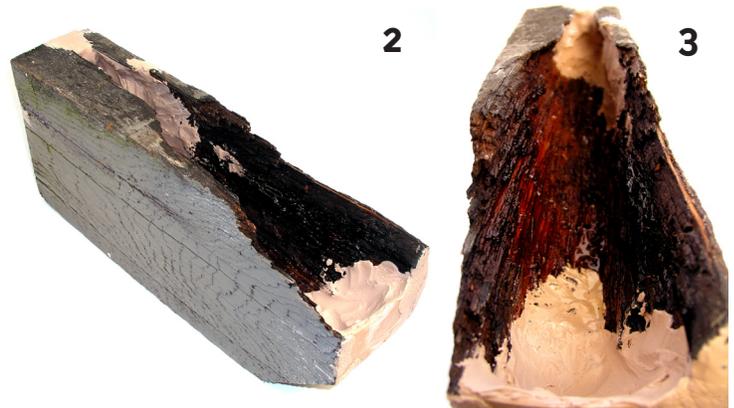
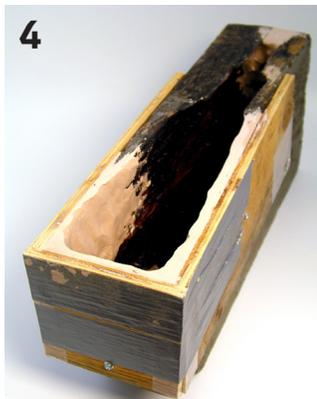
RotFix has been lavishly applied to all the rotted areas. Its low viscosity allows it to seep into all the cracks. When the RotFix was still slightly tacky SculpWood Putty was used to “dam up” the ends. We used a couple of our large plastic squeegees to establish the beam ends. These were duct taped into place and SculpWood Putty was packed against it. We used the putty to make large fillets to support the newly created partial face on the diagonal end shown. The putty on the inside towards the back was used to secure the floppy side caused by the crack mentioned above. We used a couple of stir sticks held in place with push pins to set the floppy face to the correct width. The putty fillet in front stabilizes the forward end of the floppy side.

This shows how the top edge and upper corners are re-established using plywood mold boards. The mold boards are covered with 2 inch wide packaging tape to act as a release for the applied SculpWood putty. The boards are affixed with hex head wood screws. Duct tape is used to hold the upper part of the end board to the side boards. Note that the top edge of the boards lies right at where the top edge of the rotted beam once was. This is achieved by using the remaining edge of the beam as seen in the rear portion of the photograph. About a half inch of SculpWood Putty has been applied to the shiny side of the packaging tape. (The sticky side is against the plywood.) The top part of the putty was applied slightly above the plywood edge and then sanded flush to establish the new edge. The plywood can be removed after sanding. We left it on for the next step.

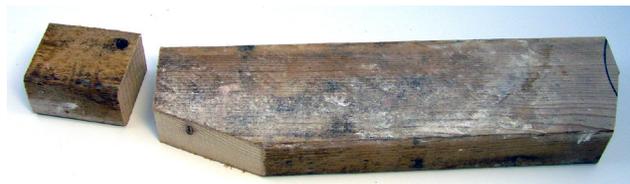
The cut 2 x 4's will be used along with SculpWood putty to fill the interior.

The plywood set into the cavity. These cheap boards replace the volumetrically more expensive SculpWood Putty. Here they are dry-fitted. Note that they lie below the top surface by about 1/4 inch. The boards will be removed and a layer of SculpWood putty will be applied to the bottom. The boards will be shoved into this and the putty pushed into the cavity between the board sides and the putty applied in Photo 4. The putty will fill the two cavities to about the top of the boards.

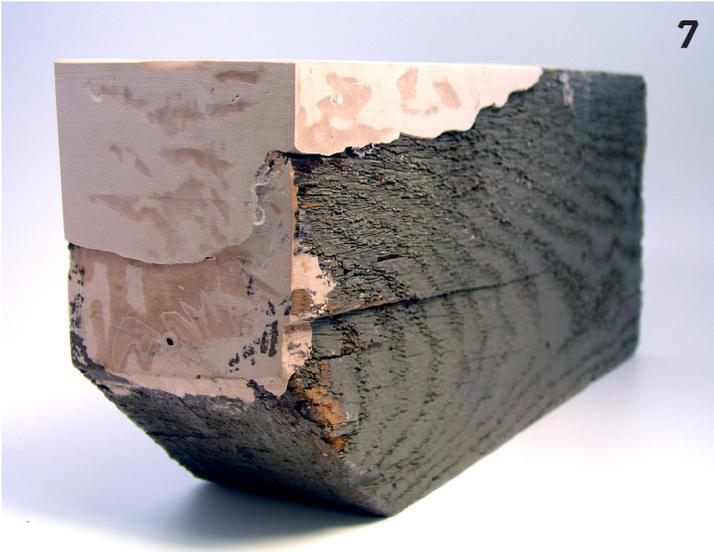
The plywood mold boards have now been removed and the SculpWood sanded to “clean it up” The edges on the sides and end of the beam exist because the beam was slightly concave. These will be “faired” in later using SculpWood Paste. Note the split in the forward part of the beam. This is the extension on the crack mentioned in Photo 1.

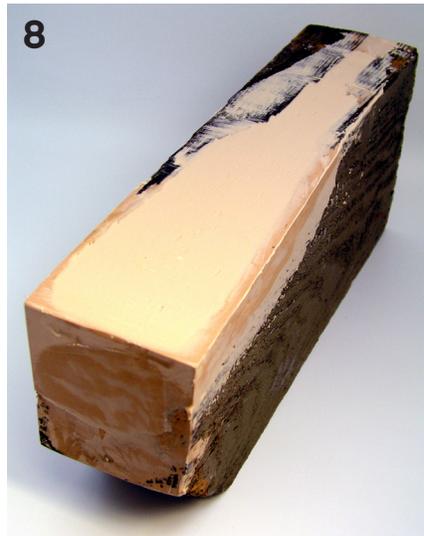
The slight recess in the top has been filled with SculpWood Paste using the newly formed edges as a guide. The side edges have been faired in.

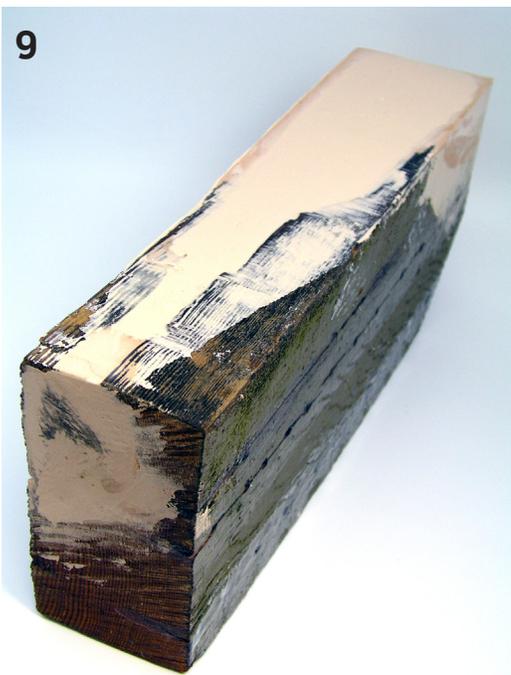
Same repair state as Photo 8. Note the line of holes that have been drilled along the crack. These were sized such that the mixer tip of a cartridge of SilverTip GelMagic adhesive could be seated in the hole allowing GelMagic to be injected into the crack. This both sealed the crack and bonded the two sides together. At this point all the strength has been returned to the beam.
